BORE FINISH

BORE FINISH (Cont.)

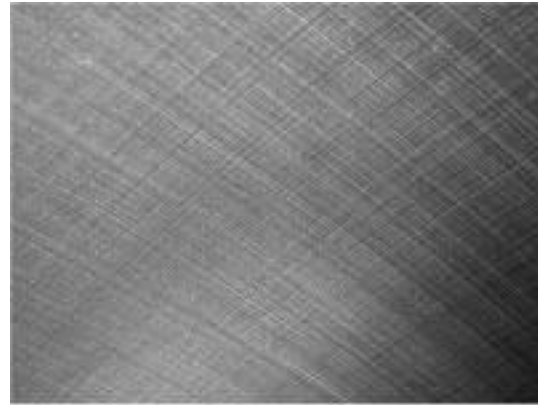
(Cross Hatch Angle data provided by Sunnen Products Company)

Cross Hatch Angle

- Typical automotive application: 45° to each other (or 22° to 32° to the horizontal deck surface)
- Crosshatch angle should be the same throughout the length of the cylinder and not flatten out at either end
- Performance racing low tension rings: 20°-30°
- Nikasil – Thermal Spray Bores – Hypereutectic Bores: 10°-15°
